# A Case Study in Robotic Mapping of Abandoned Mines Groundhog

Field Robotics Center  
Robotics Institute

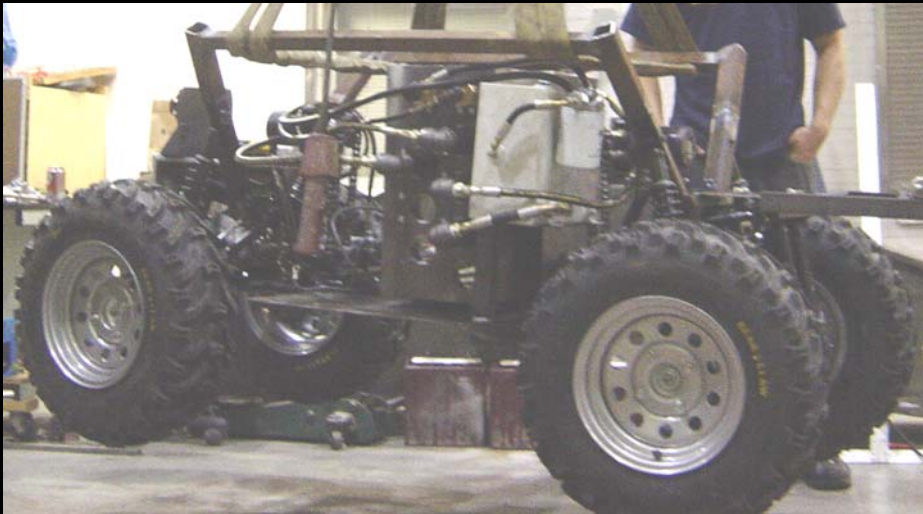
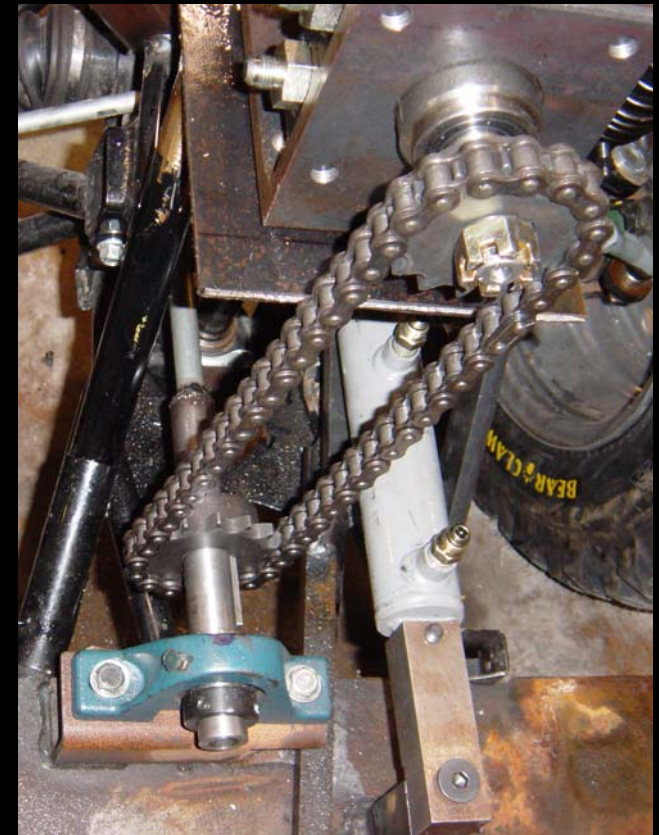
# Chassis and Locomotion

- 2 ATV fronts welded together
- 4 wheel drive & steer
- Hydraulic actuation

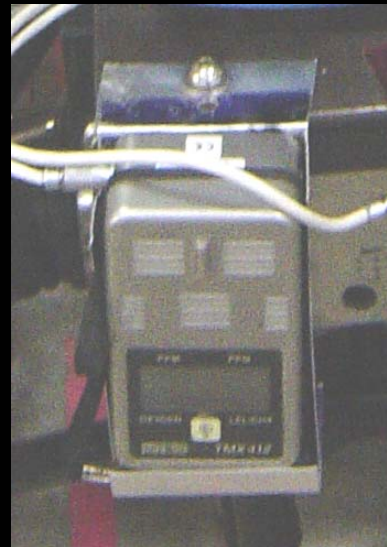
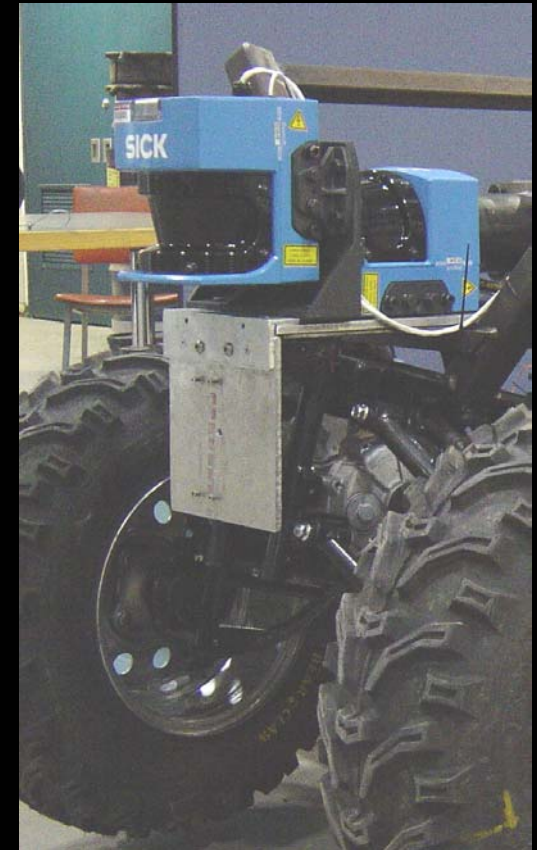
# Electronics and Sensing

- Explosion-Proof Enclosure
- Combustible Gas Sensors
- Scanning Laser Rangefinders

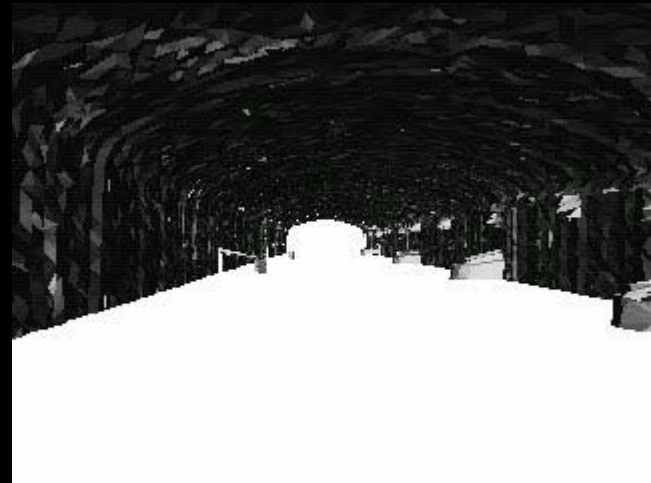
# Bruceton Mills

←→  
100 Meters

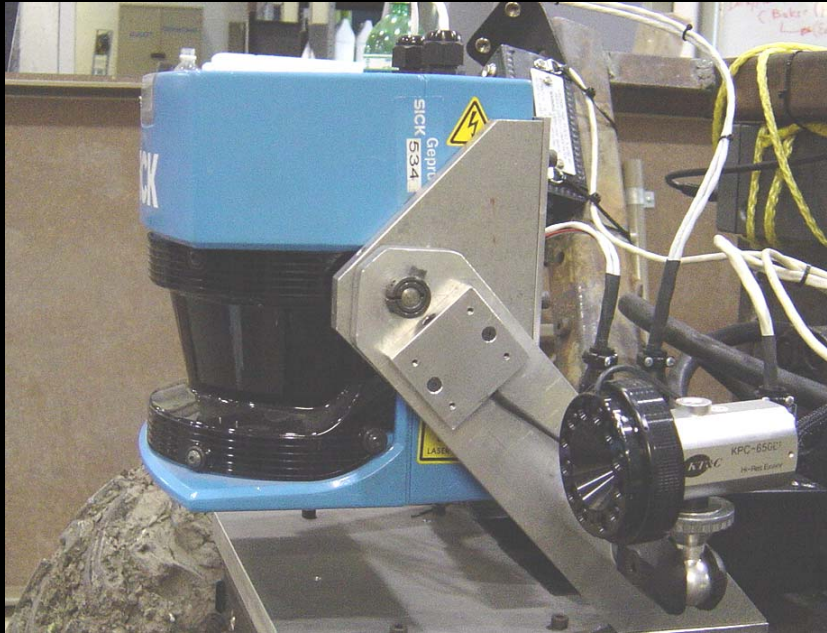
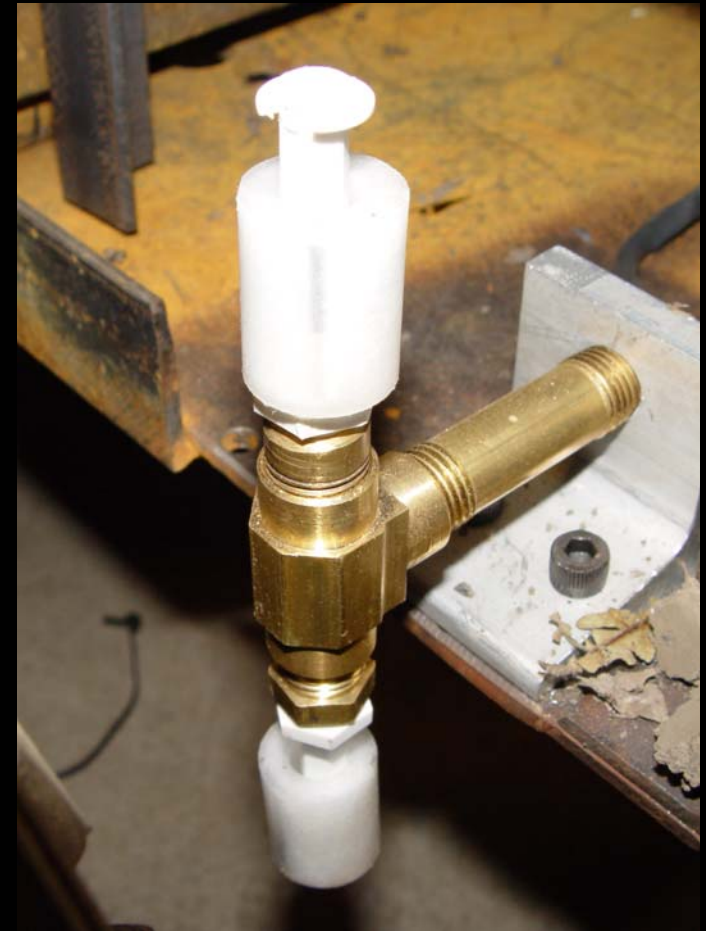
# Sensor Reconfiguration

- Single laser on a tilt unit.
- Low Light Camera
- Gyroscope
- Sinkage Sensors
